Volumetric and landscape-ecological diachronic analysis of a historical artificial water reservoir Evička in Slovakia

The present study focuses on the analysis and evaluation of the changes in the retention volume of the water reservoir Evička, the ecosystems of littoral, sublittoral and profundal zone as well as the changes in the land cover of the riparian zone and reservoir basin. The changes in reservoir volume were determined on the basis of a comparison of the actual bottom's topography, acquired through field surveying with the bottom's topography from the maps for a 40-year period (1971-2011). The volume of the sediments deposited in the water reservoir Evička for given period is 10917 m³. The changes in the landscape structures of riparian zone and reservoir basin, identified on the basis of the analysis of aerial measurement pictures, orthophotomap and field survey, were evaluated for the period of 1949-2012, i.e., 63 year. It is evident from the analysis of the landscape structure changes in the whole reservoir basin that the area of developed surfaces increased by 11.2% and the surface area of water reservoir Evička decreased by 1165 m² during that period. We interpret

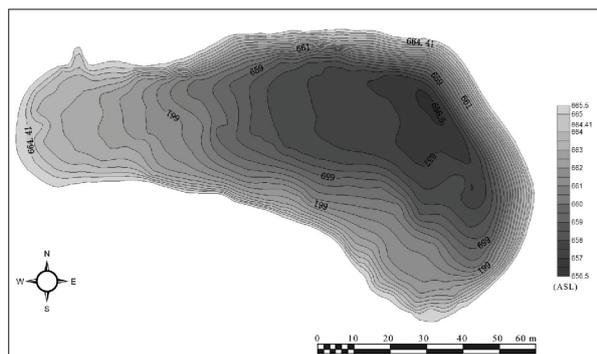
Figure 3. The detail of the topography of water reservoir Evička's bottom (condition in 2011)

We acquired the following models with computer visualisation of the bottom's topography. The greatest change in the topography occurred in the area of the greatest depth (Fig. 3). The course of contour lines with the height above mean sea level of 657 m a. m. s. l. and 657.5 m a. m. s. l. is significantly modified and their outlines prove the shallowing of the water reservoir's central part by at least 60 to 80 cm. It proves that the significant part of deposited material is

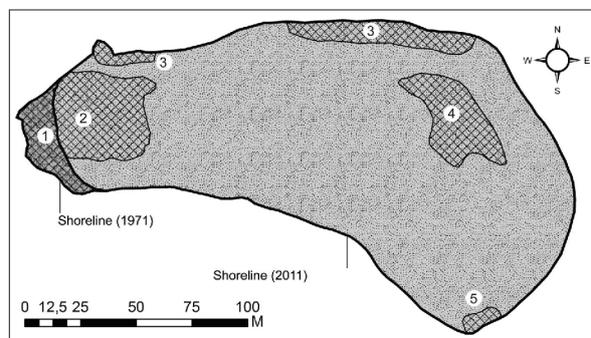
Figure 6. Changes in the water reservoir Evička's ecosystems

1. The water surface from 1971 was transformed to a terrestrial ecosystem fully filled with soil, located

behind the shore line, due to sedimentation processes. Its land cover is represented by bushy vegetation, the substrate consists of fine sandy sediment but also spreading gravel for the winter maintenance of roads. Thus, the water ecosystem became a terrestrial one during the monitored period. Today, this part is overgrown with common reed (*Phragmites communis*) and fast-growing natural seeding tree species.

2. The area of significant shallowing, acquired through the comparison of 3D elevation models of the bottom. We expect the presence of fine mud sediments and due to a more significant decrease in depth also change in temperature and light regime.

3. The increase in the presence of the wood vegetation and the possibility of the organic mass falling into the water reservoir. The detritus can cause local short-term changes in the water's pH. The increase in shading did not occur due to the shore oriented to the north.

4. The deepest part of the water reservoir shrank and became shallower due to the silting and deposition of sediments. The deepest parts of the water reservoir are the environment for the wintering of cyprinids and therefore their changes and the gradual decrease of depth will affect mainly these species.

5. The area near the adjusted outlet gully of safety spillway. Because the outlet gully is the only outlet, we can expect the sedimentation of the finest material in its close surroundings due to the flow of water.

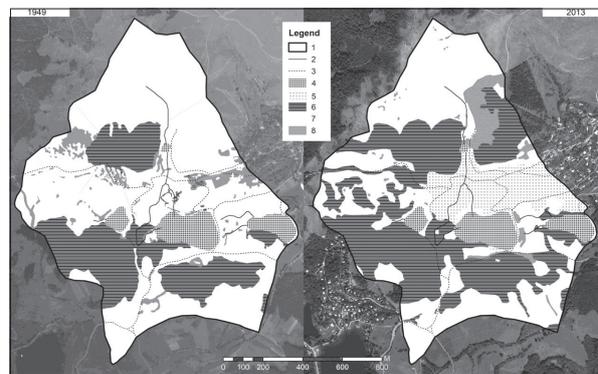
In accordance with the analysis of landscape structure changes in the whole reservoir basin (Fig. 7 and Table 3), the amount of developed surfaces increased significantly by as much as 11.2%. The development conditioned by the adjustment of slopes and roads mainly on meadow and pasture surfaces has probably the greatest influence on the amount of sediments deposited in the water reservoir. The trend of gradual development and the change of the surroundings to urban area will probably continue also in future. Therefore, it is necessary to look for such water management measures that will focus more on capturing the sediments already before the entry into the water reservoir than on the reduction of their creation. It should be noted that there is no longer a water reservoir below the water reservoir Evička today. In the past, there was a water reservoir bottom Vindšachta approximately 500 m below in the direction of valley, but today it is completely filled up. The possible decrease in the amount of sediments with flushing the water reservoir could be considered, it would not mean the sediment transfer from the upper to the lower water reservoir. We assess the increase in afforestation in the reservoir basin by 14.5% positively. It concerns mainly fast-growing tree species. In the reservoir basin has occurred a significant reduction in the surface area of meadow vegetation from the original 66.5% of the overall surface area to 41.8%, whereas 13.17% of meadow vegetation was built up and changed to municipality's urban area and 20.85% of the surfaces were forested.

Figure 7. Changes in the water reservoir Evička's reservoir basin
Legend: 1) the boundary of reservoir basin, 2) roads, 3) streams, 4) water surface, 5) developed area, 6) forest vegetation, 7) meadows and pastures, 8) bushes

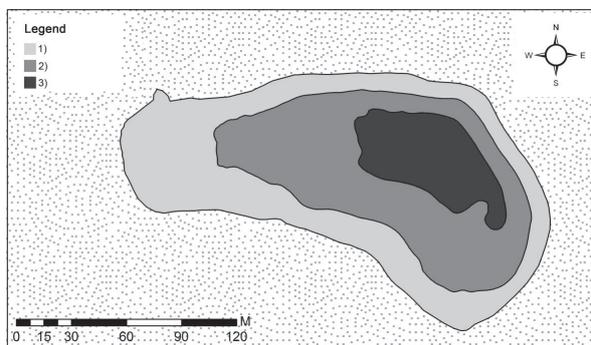
Figure 9. The stratification of the water reservoir Evička in 2011 Legend: 1) littoral zone, 2) sublittoral zone, 3) profundal zone

Surface category	Surface area [m ²]		Change of area [%]
	1971	2011	
Littoral	4,830	7,384	52.87
Sublittoral	12,264	9,065	-26.08
Profundal	3,065	2,797	-8.74
Total	20,160	19,248	-4.52

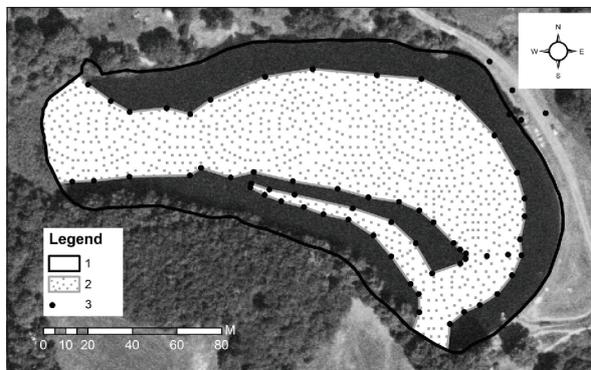
The distribution of the sediments in the area of the water reservoir and the expected direction of their supply and subsequent accumulation was visualised (Fig. 10). Two sources of sediments can be observed, one in the western part

of the water reservoir in the places of the feeder gully from upper water reservoirs and one in the southern side, where the transfer of sediments from surrounding slopes occur. The distribution of sediments is unequal due to a slight inclination in the bottom's topography. The sediments deposited from the western part do not have enough kinetic energy capable of their transfer over the bottom of this inclination and they are transported further towards the deepest parts of the water reservoir. The field survey at the drained water reservoir Evička's bottom has shown the occurrence of spreading material in the most western part. The sediments deposited from the southern part are re-deposited in the deepest parts and only a small part of it accumulates at the inclination's dam crest in the bottom's topography.

Figure 10. Distribution of sediments in the water reservoir's area Legend: 1) Shore line in 2013, 2) the boundary of accumulated sediments, 3) topographical points

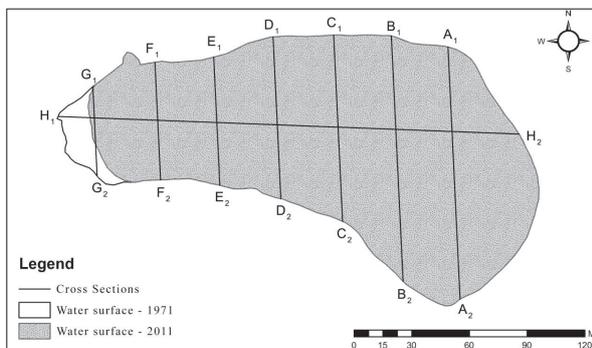
Section	Sediment thickness [m]		
	Max	Average	Standard sample deviation
A	1.17	0.75	0.44
B	1.09	0.64	0.95
C	1.27	0.56	0.90
D	1.31	1.1	0.87
E	1.42	1.5	0.89
F	1.21	0,57	0.85
G	1,40	1.2	0.40
H	1.31	0.59	0.32

Figure 12. Location of selected cross section lines of water reservoir Evička
